STREET COMMITTEE AGENDA Tuesday, October 24, 2023 at 6:00 PM Adel City Hall, 301 S 10th Street, Adel, IA 50003

MEMO

Of all urban areas in the state, the City of Adel ranks near the middle and is considered to have *average pavement conditions*, based on the lowa Pavement Management Program's (IPMP) condition assessment. Recent development and some history of rehabilitation activities have allowed the City to maintain a road network of high average quality. It is a desire to continue providing high quality infrastructure for its citizens that led Adel to contract with *HR Green, Inc.* to improve their pavement management program.

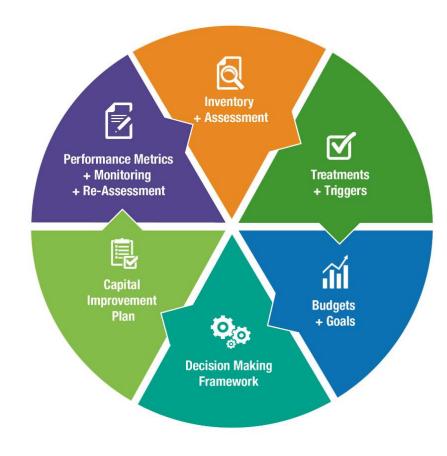
Figure 1: Primary Components of Pavement Management
The diagram above illustrates the six primary components of pavement management

The diagram above illustrates the six primary components of pavement management. Details of the components can be found in the methodology section

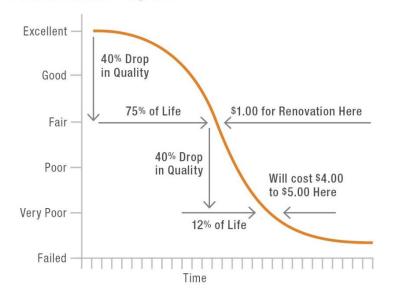
Figure 2:Performance Curve

Renovating a pavement in "Fair" condition will usually cost less than 25% of reconstructing a failing pavement.

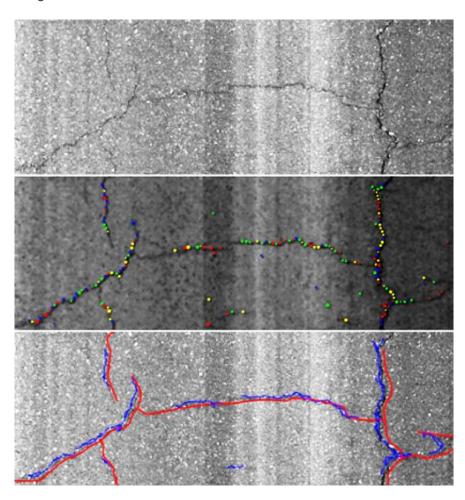
Figure 4: Automated Crack Analysis Software
This picture is a screenshot of an automated crack detection software that uses elevation information and photogrammetry to identify distresses and categorize their severity

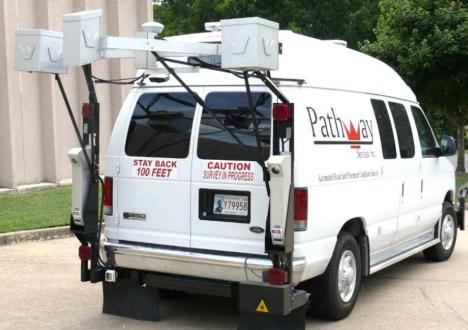
Figure 3: A "Pathrunner" Automated Data Collection Vehicle (Pathways)
This is one of the van's that a previous data collection vendor used to collect pavement condition in lowa from 2013-2017.

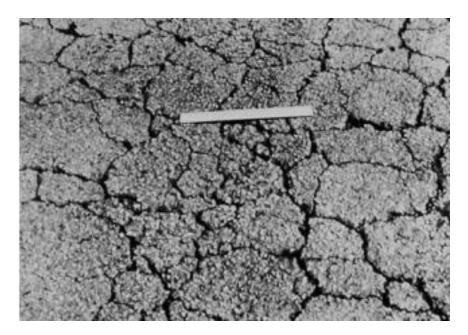
Figure 5: Example of Alligator Cracking (ASTM)

This image is from the ASTM D6433 "Standard Practice for Roads and Parking Lots Pavement Condition Index Surveys." Alligator Cracks are when pavement breaks into a "scaly" pattern typically caused by fatigue, either from repeated heavy loads, lack of sufficient subgrade support, or weakened material due to drainage issues.

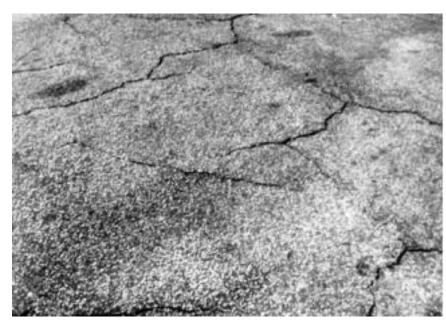
Figure 6: Example of Block Cracking (ASTM)

This image is from the ASTM D6433 "Standard Practice for Roads and Parking Lots Pavement Condition Index Surveys." Block cracks are when pavement breaks into "chunks" or "blocks" that are roughly rectangular, caused by internal stress from temperature or lack of lateral support.

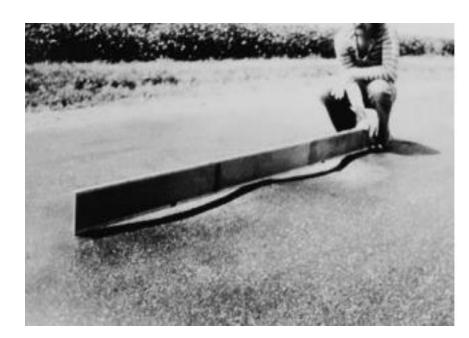
Figure 7: Example of Distortion (ASTM)

This image is from the ASTM D6433 "Standard Practice for Roads and Parking Lots Pavement Condition Index Surveys." Distortions are when the pavement warps its shape without much cracking. Typically caused by shifting or displaced underlying material.

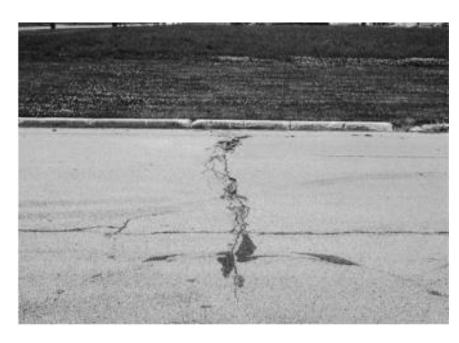
Figure 8: Example of Transverse Crack (ASTM)

This image is from the ASTM D6433 "Standard Practice for Roads and Parking Lots Pavement Condition Index Surveys." A common distress caused by a wide variety of issues.

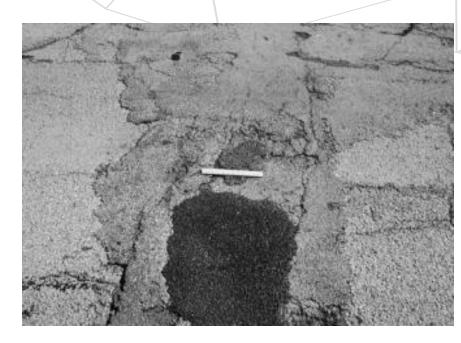
Figure 9: Example of Patching (ASTM)

This image is from the ASTM D6433 "Standard Practice for Roads and Parking Lots Pavement Condition Index Surveys." Patching is the result of corrective actions already taken and are indicative of underlying issues as well as a common point of failure.

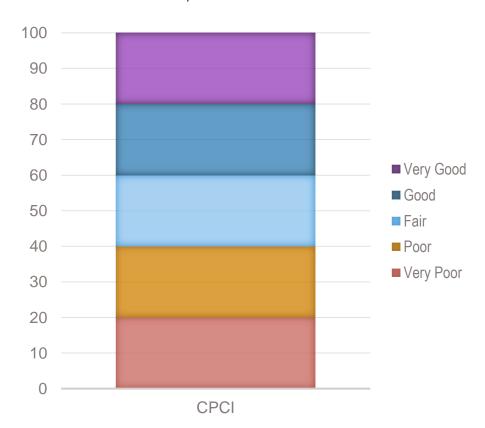
Figure 11: Condition Thresholds

This chart shows the proposed relationship between CityPCI, and the condition categories used in this plan.

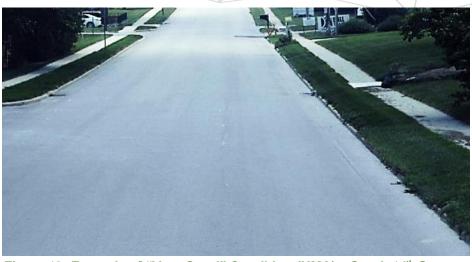
Figure 12: Example of "Very Good" Condition (HMA) – South 14th StreetThis picture was taken from the 2021 data collection records. South 14th St near Greene has a very high PCI of 92 /100 because it demonstrates no visible pavement distresses. Likely because it was overlayed recently.

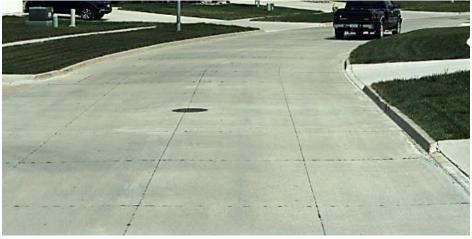
Figure 13: Example of "Very Good" Condition (PCC) – Shelby Drive
This image from the 2021 data collection shows Shelby Dr near Meadow. It was rated as a-perfect
100/100 and would be considered "Very Good" for a PCC pavement.

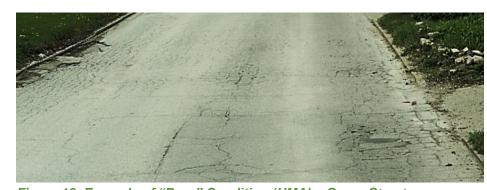
Figure 18: Example of "Poor" Condition (HMA) – Grove Street
This image shows an HMA street whose pavement is rated as 30/100 and considered to be in "Poor" condition. Grove Street east of 15th has significant alligator cracking and distortions along the wheel path and pavement edge affecting the ride.

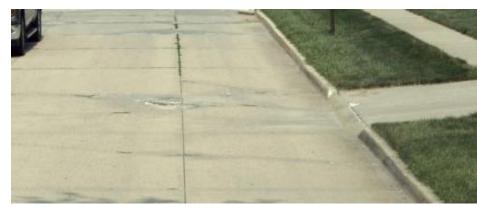
Figure 19: Example of "Poor" Condition (PCC) – North 17th Street
This image is an example of a PCC pavement in "Poor" condition. In 2021, the section of N 17th St shown had a PCI of 26/100 due to joint failures.

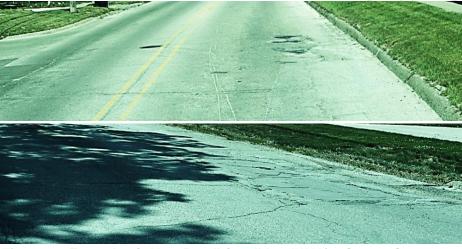
Figure 20: Example of "Very Poor" Condition (HMA) – Greene Street
This image shows an HMA street whose pavement is rated as 20/100 and considered to be in "Very Poor" condition. Greene St west of 11th is considered the worst HMA surface street in Adel due to deep ruts and large localized failures.

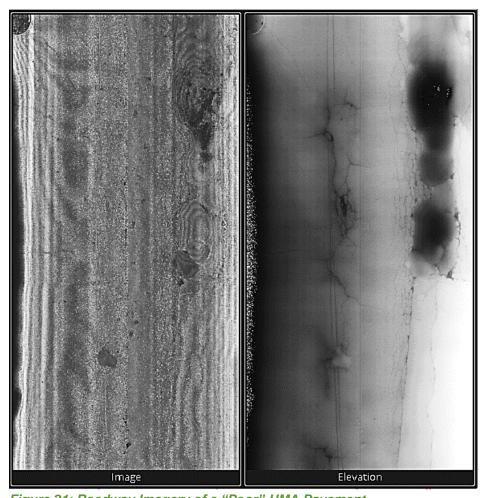
Figure 21: Roadway Imagery of a "Poor" HMA Pavement
This imagery is from the section shown in Figure 20. These were captured by the data collection vehicle's downward facing camera (left) and LIDAR array (right). These are one of the key resources used in evaluating pavement condition.

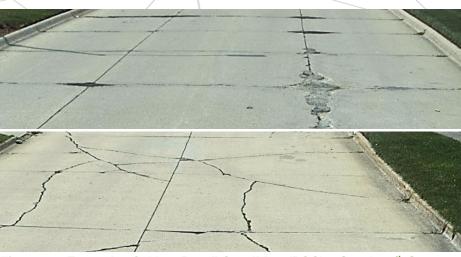
Figure 22: Example of "Very Poor" Condition (PCC) – South 16th Street
This image is an example of a PCC pavement in "Very Poor" condition. South 16th St south of Hyvue
is considered the worst condition road in the system due to widespread joint spalling, d-cracking,
most panels are cracked..

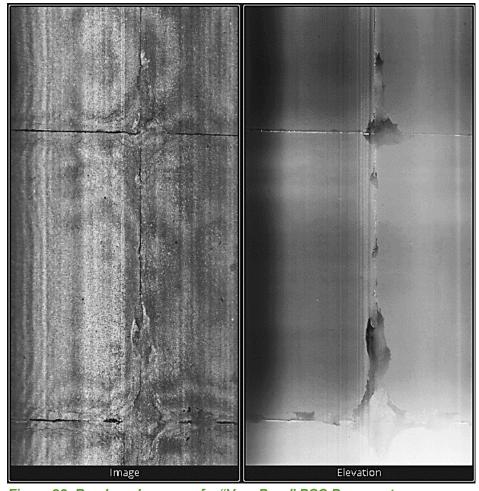
Figure 23: Roadway Imagery of a "Very Poor" PCC Pavement
This image is from the section shown in Figure 22. These were captured by the data collection vehicle's downward facing camera (left) and LIDAR array (right). These are one of the key resources used in evaluating pavement condition.

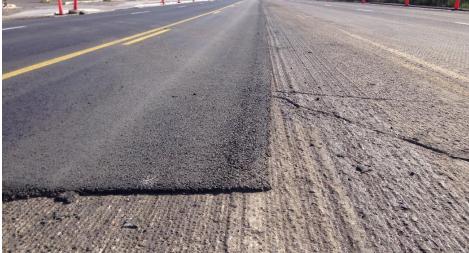
Figure 28: HMA Overlay Placed On Milled Pavement (Famartin)
This is a picture of an asphalt overlay placed on I-80 through Elko, Nevada after part of the original pavement was milled off.

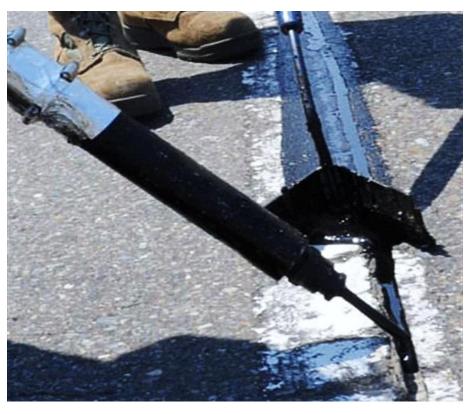
Figure 36: Crack Sealing Performed W/ Routing (USAF/Kenna Jackson)
This is an example of crack sealing being performed with special preparation in the form of using a router to clean up the crack profile, as being performed by 35th Civil Engineer Squadron.

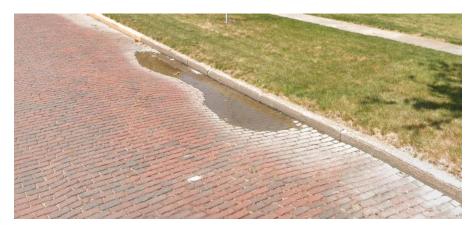
Figure 40: Area Distortion of Rapids Street Holding Water
This area has distorted enough to catch and hold water, which indicates it will likely continue to fail as water and frost undermine the subsurface support.

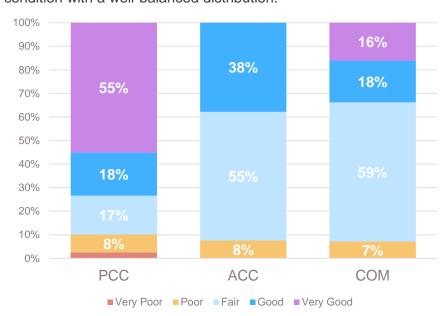
Figure 47: Condition Distribution by Pavement Type
This figure shows the distribution of pavement conditions for each of the four pavement types.

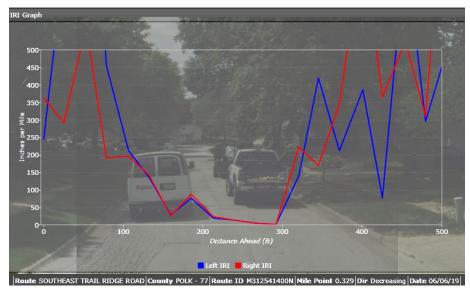
Figure 53: Roughness Profile Affected by Local Driving Conditions
This Image was taken from Iowa DOT Pathweb showing a road where the collection vehicle was
trailing a delivery van and weaving around parked cars causing a sudden change in roughness.

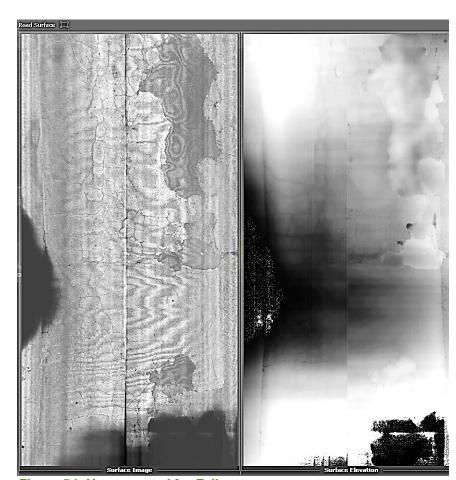
Figure 54: Unaccounted for Failure

These images are of a failure are not included in the pavement rating for the associated road.

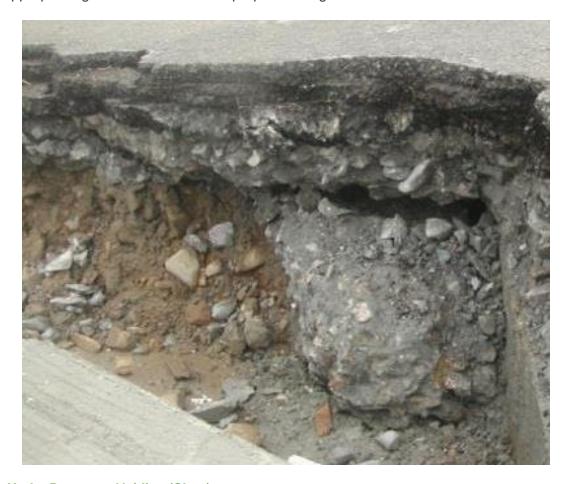
Figure 61: Under Pavement Voiding (Chen)
This photo shows a pavement void that has formed along the bottom of a pavement due to subgrade issues.

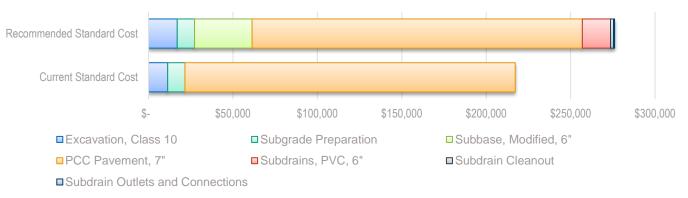
Figure 63: Recommended Vs. Current Standard Cost Comparison – Two Block 900' Segment This diagram shows the breakdown of the costs incurred by the different design standards

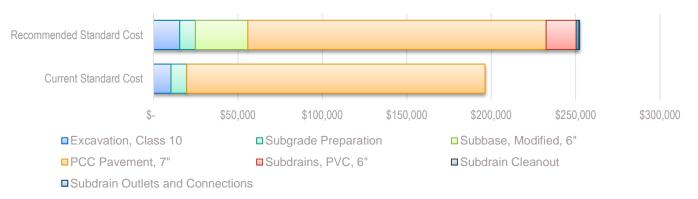
Figure 64: Recommended Vs. Current Standard Cost Comparison – One Block 870' Segment
This diagram shows the breakdown of the costs incurred by the different design standards

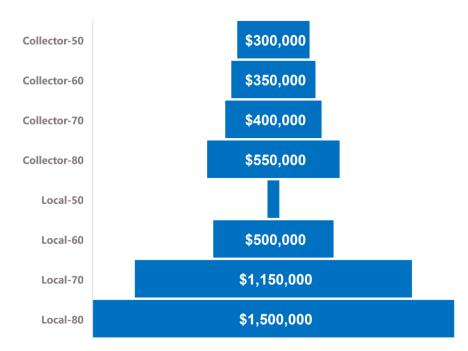
Figure 75: Est. Costs to Maintain Certain Condition Levels by Class
This figure shows the dTIMS cost results rounded to the nearest \$50k in order to maintain a
certain average condition level based on the functional class. To determine total cost, add 1
Local option to 1 Collector option.

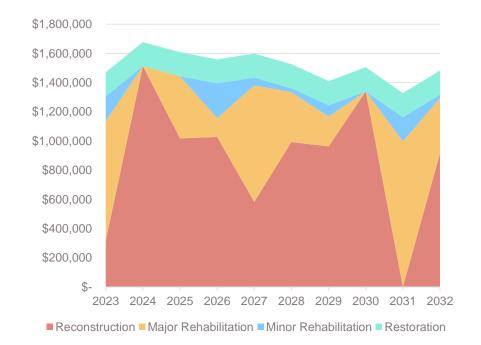
Figure 78: Treatment Type Over Time
This area graph shows the treatment distribution for each year of the CIP.
